Manhole Inspection Summary

Manhole # S41Y1_011MH

Insp Date: **11/30/07 1:38 PM**

Location Address: **3600 Brooklyn Ave**

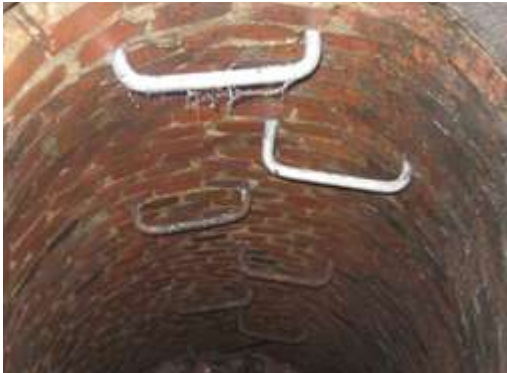
Steps Count: **7** Missing: **0** ☒ **Corroded**

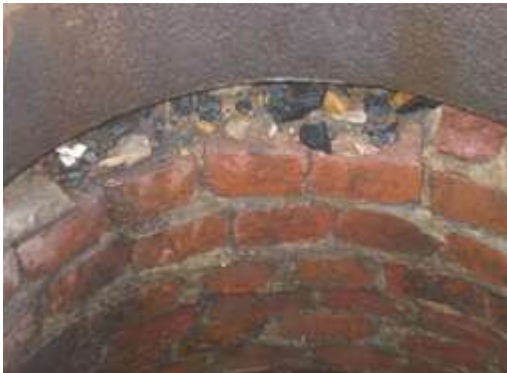
Defect 2

Condition: ☐ Sound ☐ Cracked ☐ Root Intrusion ☒ **Loose Brick** ☐ Deteriorated

Loose bricks

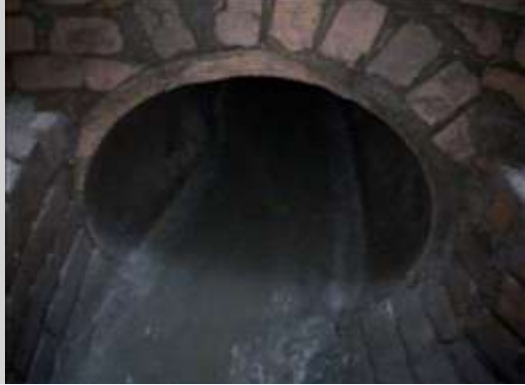
12 O'Clock Outflow

Pipe Height: **25.2** (in.) Rod and Bar (Angled)
Pipe Material: **Clay** ☐ Pipe Lined
Invert Depth: **12.66** (ft.) Flow Characteristics: **Fast**
Deposits: ☒ None ☐ Mud ☐ Sludge ☐ **Debris** ☐ Grease
Silt Depth: (in.) Deposits Extent:
Infiltration: **None** Pipe Seal Cond: **Sound**

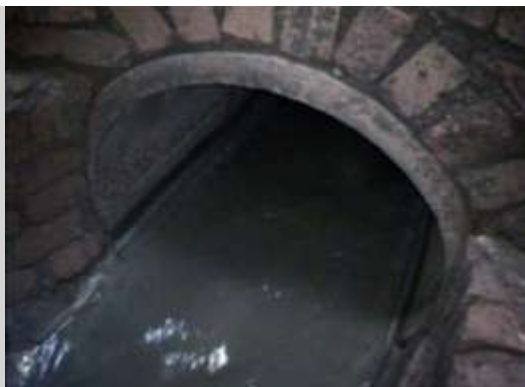
3 O'Clock Inflow

Pipe Height: **21.6** (in.) Rod and Bar (Angled)
Pipe Material: **Clay** ☐ Pipe Lined
Invert Depth: **12.28** (ft.) Flow Characteristics: **Fast**
Deposits: ☒ None ☐ Mud ☐ Sludge ☐ **Debris** ☐ Grease
Silt Depth: (in.) Deposits Extent:
Infiltration: **None** Pipe Seal Cond: **Sound**

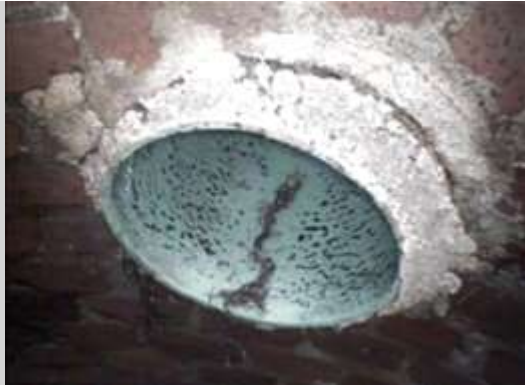
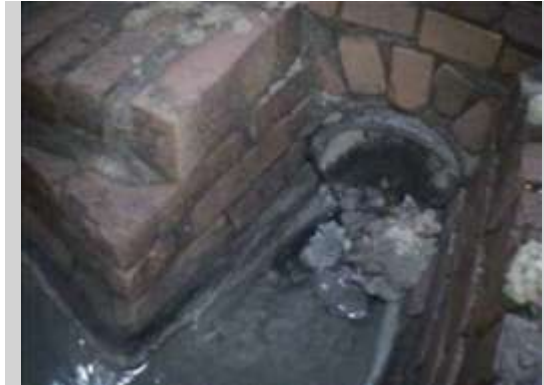
6 O'Clock Inflow

Deposits: ☐ None ☐ Mud ☐ Sludge ☒ **Debris** ☐ Grease

Silt Depth: **3** (in.) Deposits Extent: **Light**

Drop: **Outside** Rod and Bar

Drop Condition: **Open**
